PHOTO
INTERPRETATION
NOTE

HIGH-BAY BUILDING AT LA ROSITA ARMS FACTORY CUBA

NPIC/R-64/70 NOVEMBER 1970

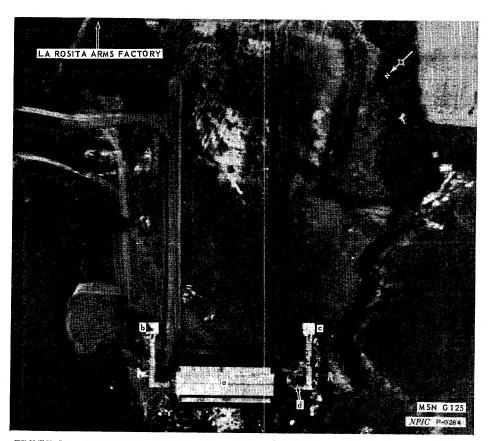
FIGURE 1. HIGH-BAY BUILDING AT LA ROSITA ARMS FACTORY, CUBA,

25X1D 2. Construction in this area began in the area included the high-bay building (Figure 1, item a), two small square buildings south of it (items b and c), probably concrete approaches connecting these three buildings, and an unpaved road serving

3. Footings and frame work for the high-bay building were observed 25X1D on photography of and the building appeared to be nearing com-25X1D pletion by . At each end of the building, below the high-bay section, a probably concrete approach extends 25X1D Each approach turns south at a right angle and extends 25X1D 25X1D to a small building (items b and c). The entranceway to these buildings slopes down, indicating that the buildings are at least partially underground. They are only 25X1D above ground

1D on By the west approach (item d) ing, was being covered over by a gable roof.

5. An unpaved road south of the high-bay building is 10 meters (33 feet) wide. It formed an approximate rectangle measuring

The road parallels the south side of the main building, which may have vehicle entrances on that side.

6. The entire area is surrounded by a single fence. A probable guard shack is at the entrance to the road, and a single guard tower is on the southwest side of the main building.

a High-bay building
Geo coords: 22-09-20N 080-04-35W
Overall measurements
Height, main roof
Height of high-bay section

b,c Small building
Entrance width
Height above ground

d Building under construction
